New York City Bank Building Fire: Compartmentation vs. Sprinklers

New York City Bank Building Fire: Compartmentation vs. Sprinklers (January 31,1993)

Investigated by: J. Gordon Routley

**This is Report 071 of the Major Fires Investigation Project conducted
by TriData Corporation under contract EMW-90-C-3338 to the United
States Fire Administration, Federal Emergency Management Agency.**

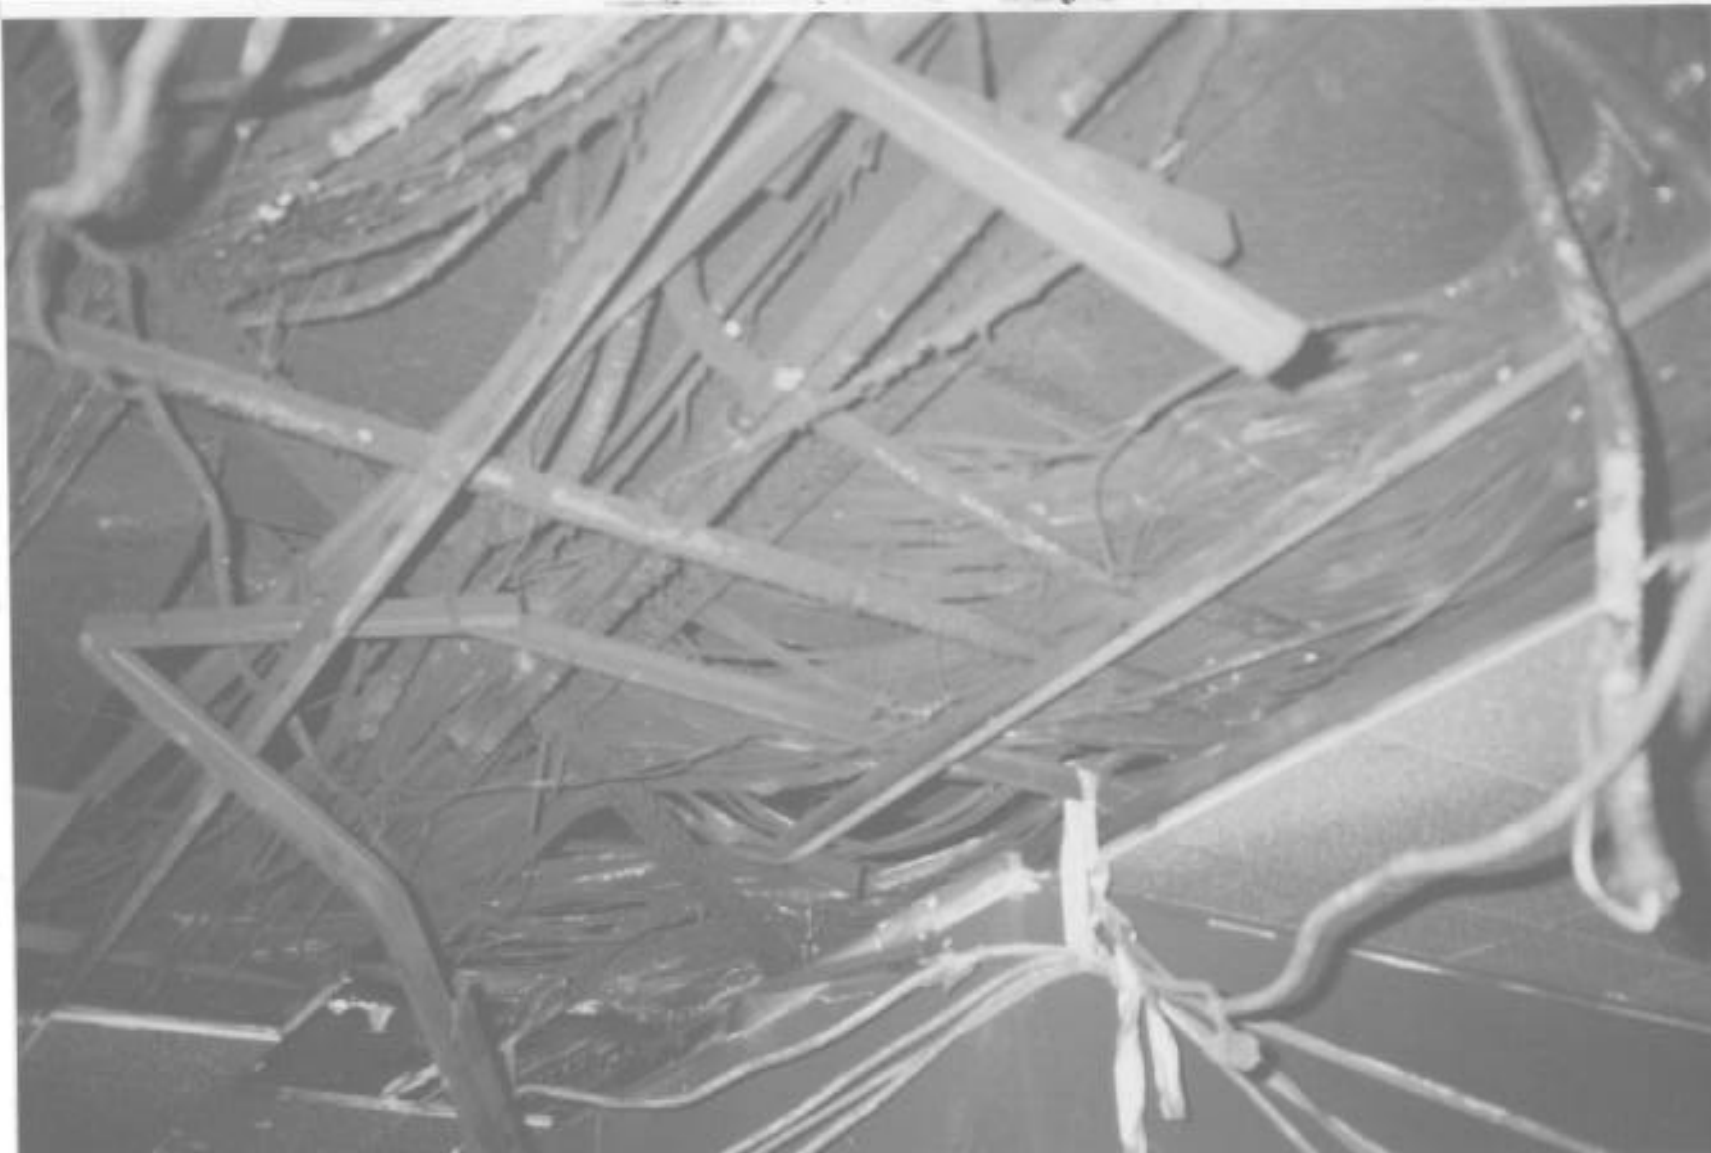
Fuel Load in Ceiling Plenum — The space above the ceiling in the fire area and adjacent areas was used for electrical wiring and communications cables. The amount of communications wiring in this type of occupancy is often a problem. It appears that over the years the amount of communications wiring in the plenum has grown, as old runs have been replaced by new wiring, but the old cables were not removed. The fuel load provided by the insulation on the wires contributed to the fire origin and intensity. The cable runs also made it impossible to fully seal the openings in fire separation walls above the ceilings, allowing smoke to migrate from one compartment to another and contributing to the secondary damage.

Photo shows the accumulation of combustible wiring that was in the ceiling plenum on the sixth floor at the edge of the fire area.

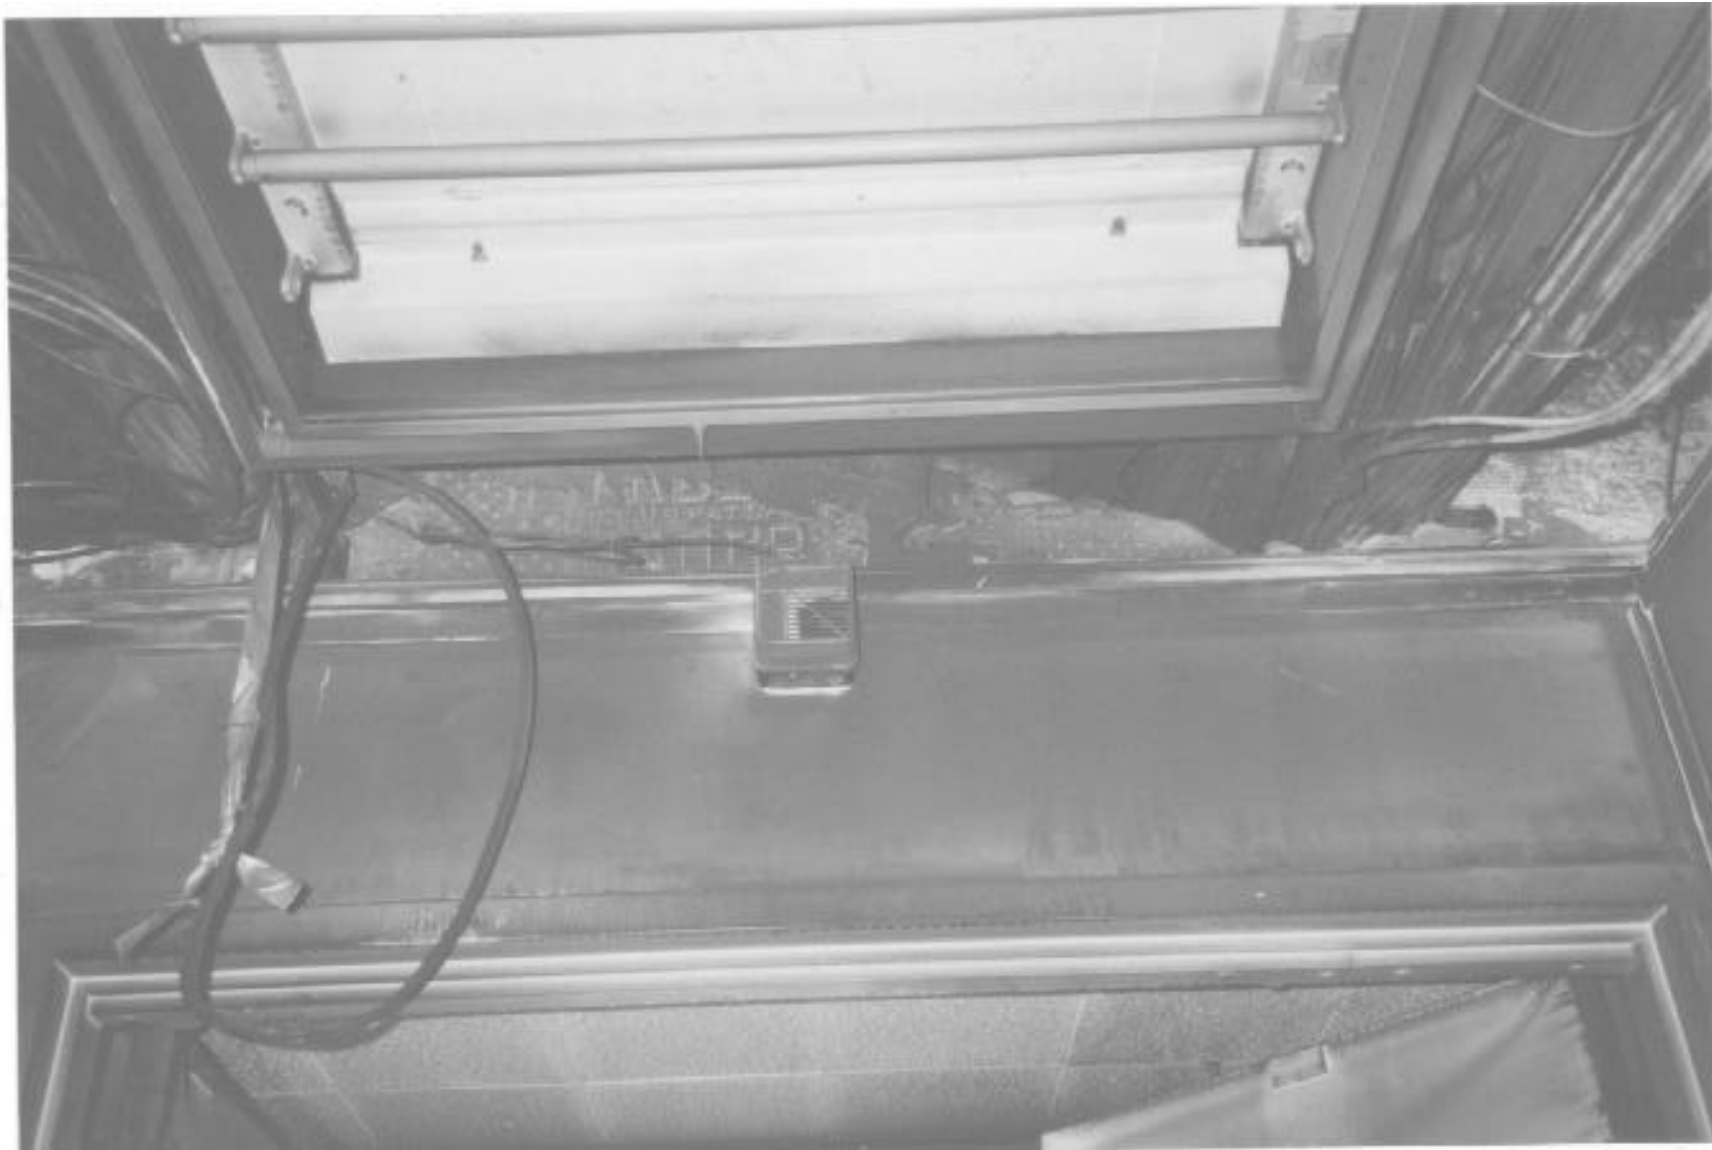
View of the ceiling plenum at the fire division wall shows the accumulation of electrical and communication wiring that penetrates the interior fire division wall above the doorway on the sixth floor.

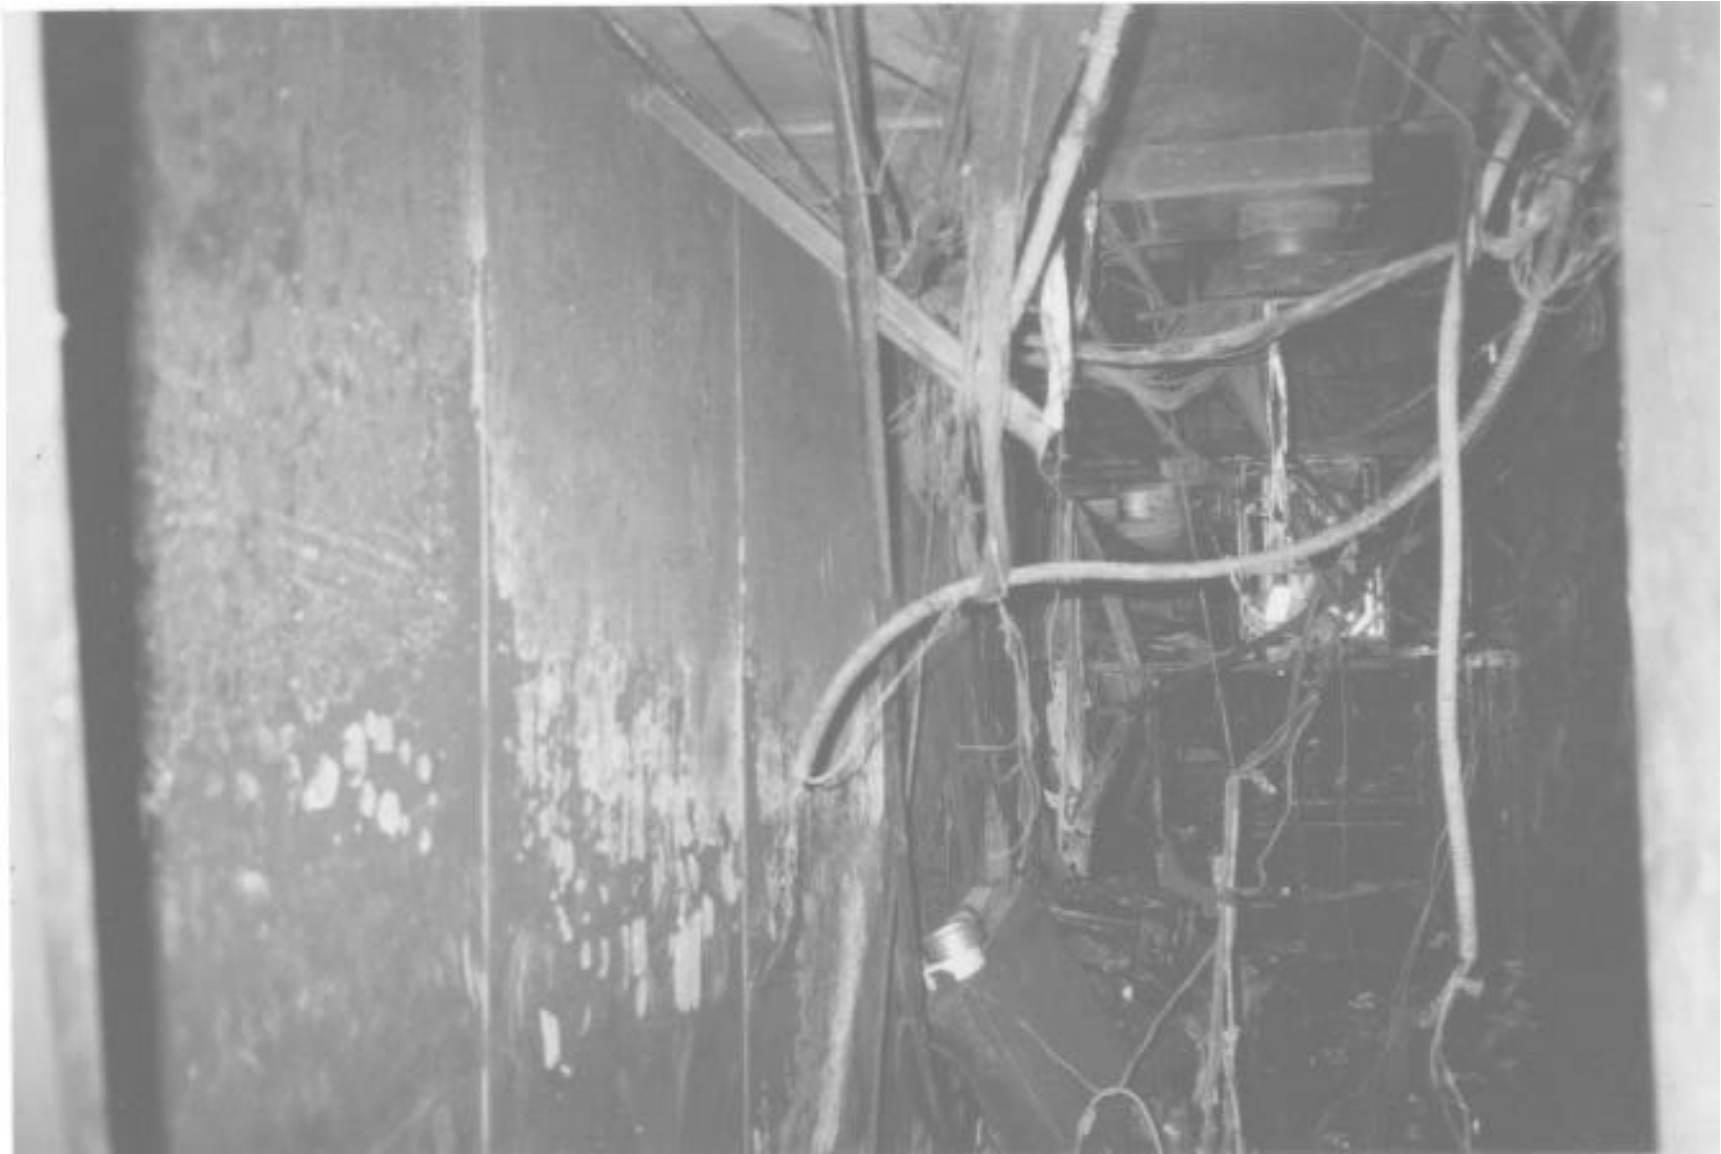
Corridor on the sixth floor where Engine 65 attempted to advance a 2 1/2 inch attack line.

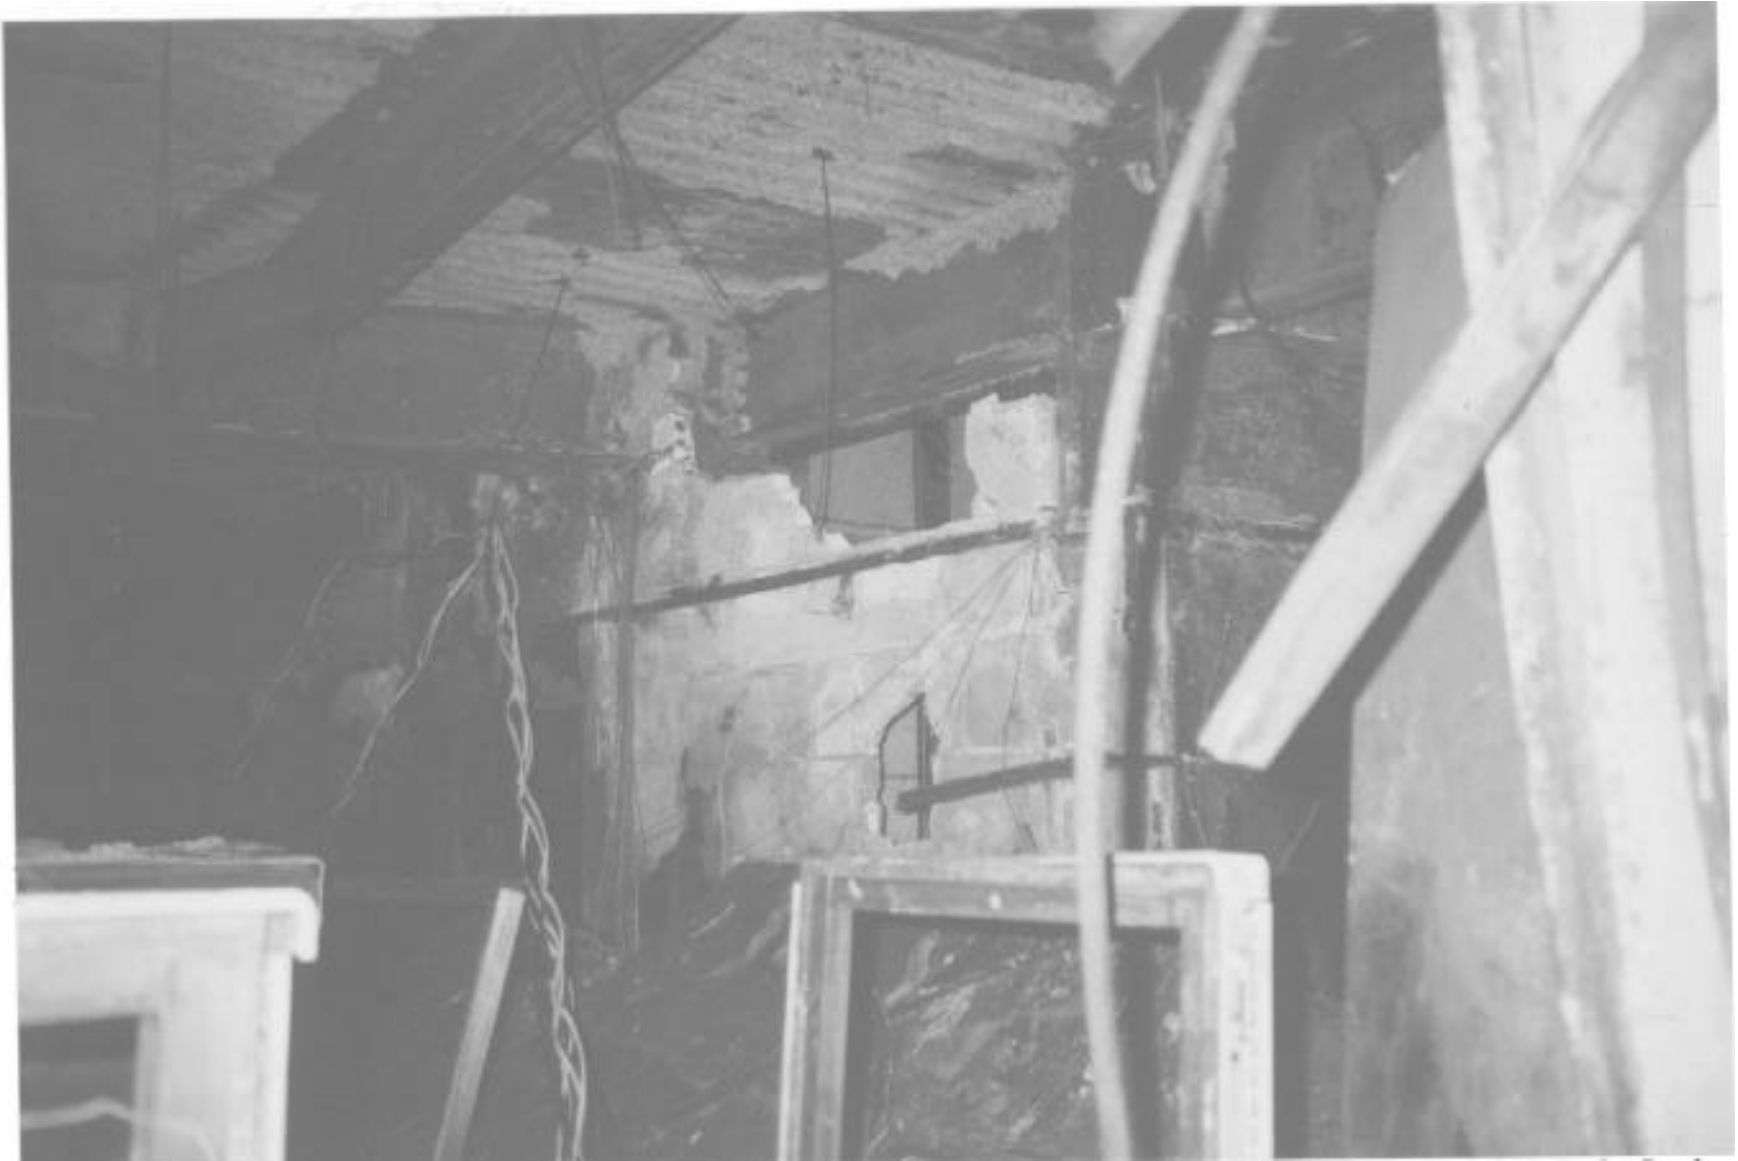
The master streams also punched a hole in the block wall enclosing the elevator shafts, directly opposite the windows, causing the blocks to fall on top of the elevator cars that were parked at the lobby level. Water runoff damaged most of the lower floors of the west tower. Electrical and telephone systems in the west tower were disrupted and needed major repairs.

Area on the sixth floor showing penetration into the elevator shafts caused by the high pressure master streams.

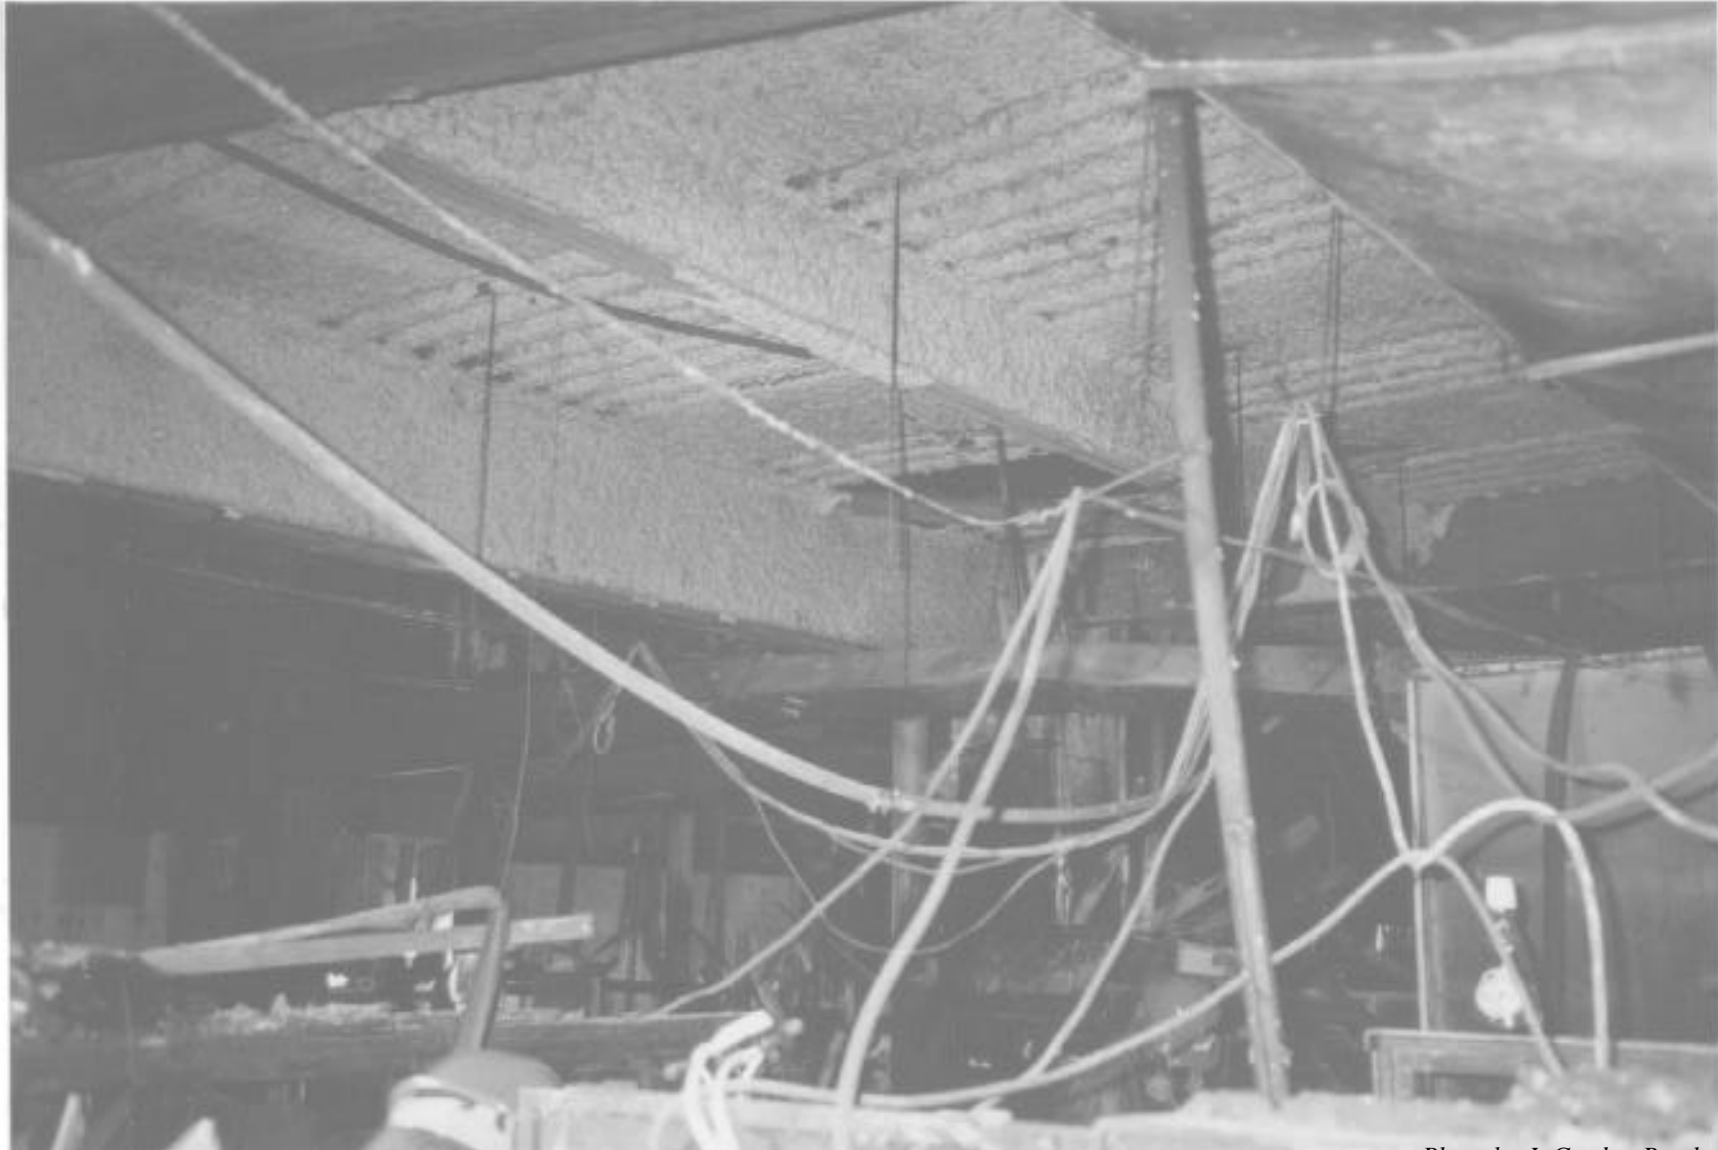
On the sixth floor, this is a view of the structural steel from the underside showing where the sprayed on asbestos fireproofing material remained attached to the steel in an area that was not exposed to water streams.

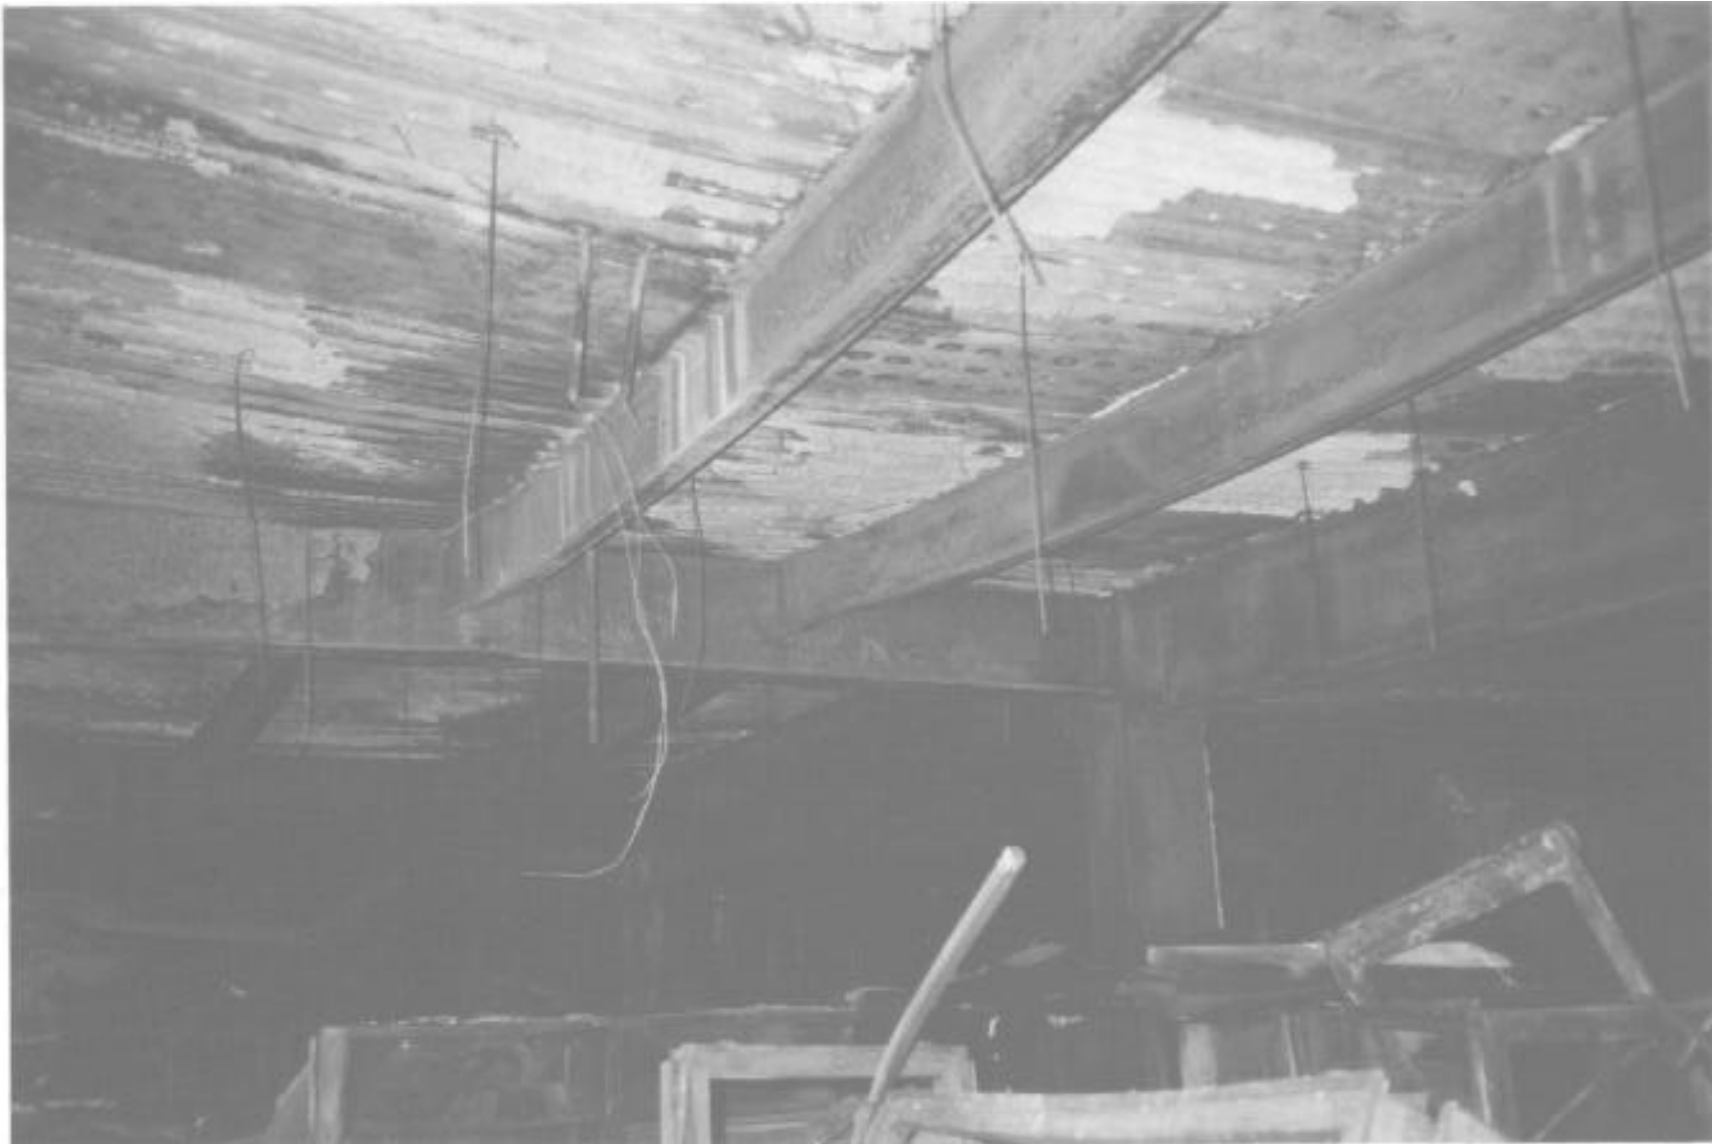
Most of the structural damage was confined to the underside of the seventh floor assembly. There was minor warping and sagging of the steel beams and larger girders, as well as sagging of the steel Q-deck between the beams. One of the smaller beams was detached from the supporting girder at one end of its span, apparently from the force of a master stream hitting it while it was heated. The deformation of the deck was most pronounced along the joints where fire had been observed extending through to the seventh floor; a variation in the floor level of three to six inches remained after the fire.

On the sixth floor, this view shows that virtually all the asbestos fireproofing was washed off the steel that was exposed to water streams. Photo also shows the deflection of the beams and floor deck above due to heat.

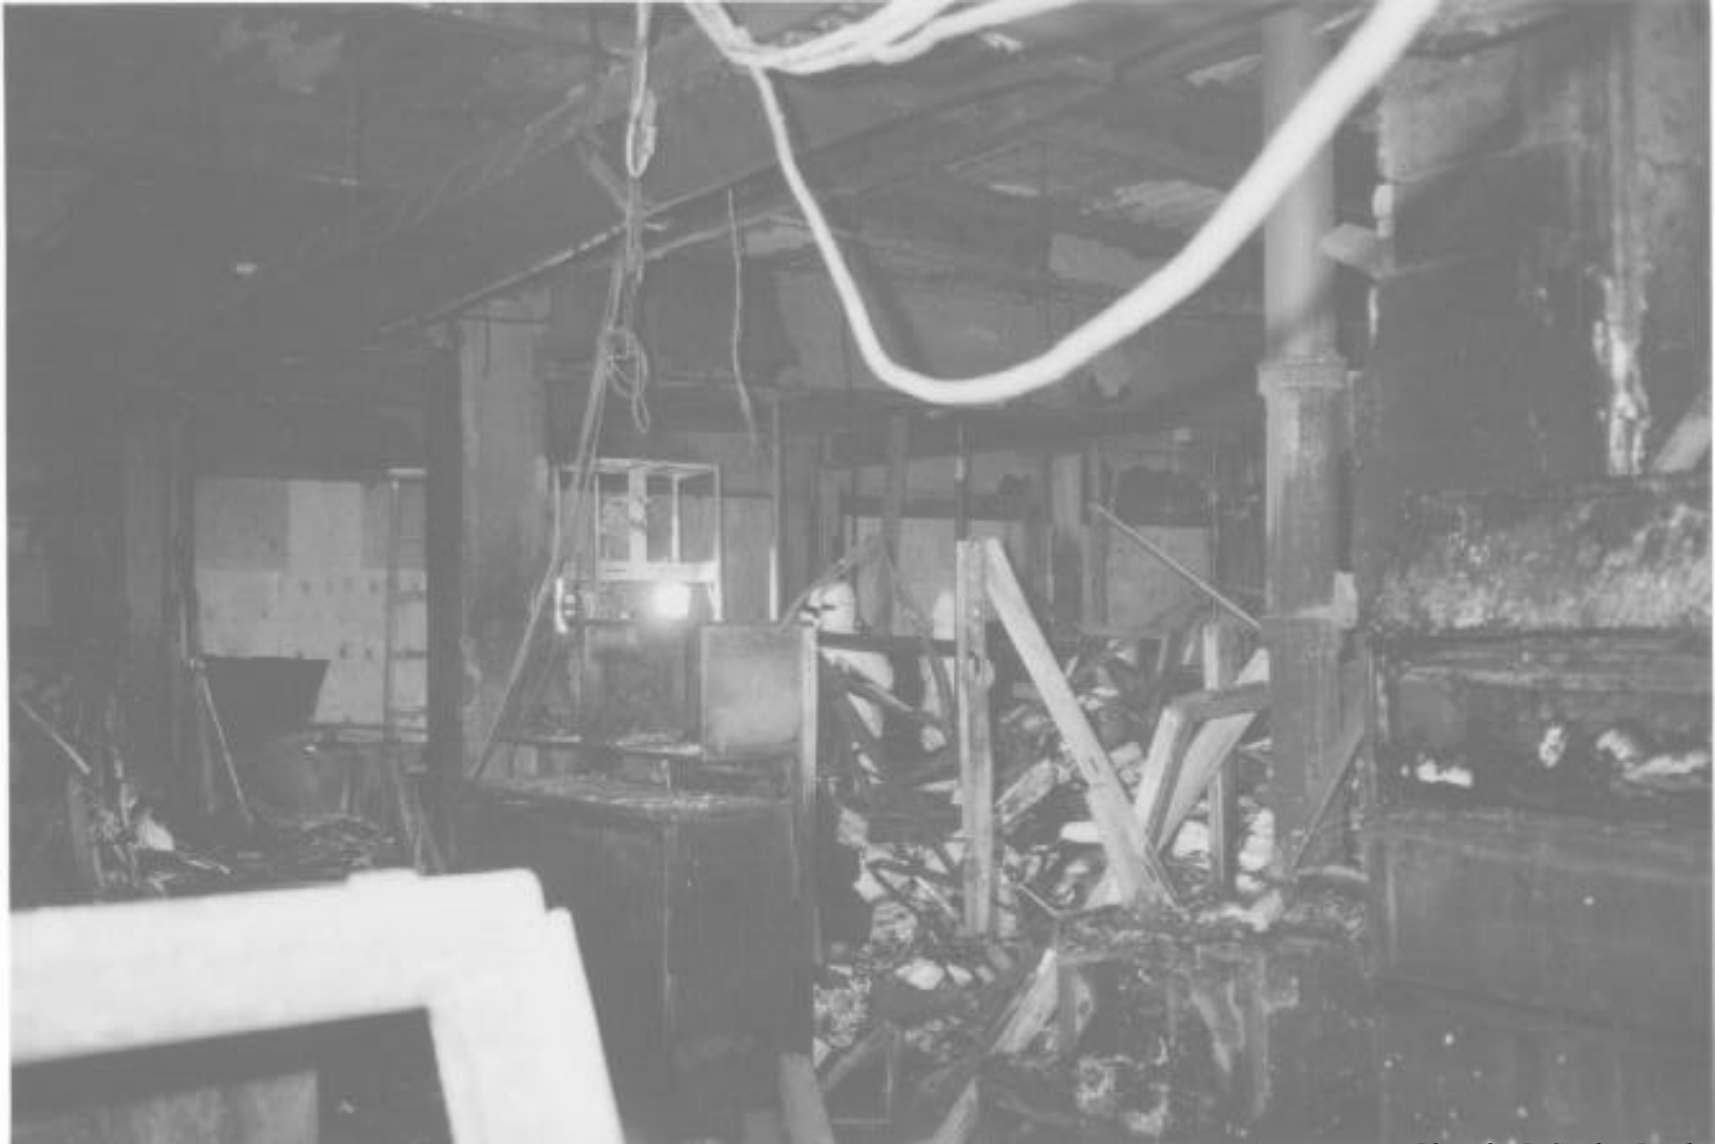
The main fire area on the sixth floor looking toward the windows on the 48th Street side of the building.
Note the degree of fire damage to contents and exposure of the structural steel above the ceiling.

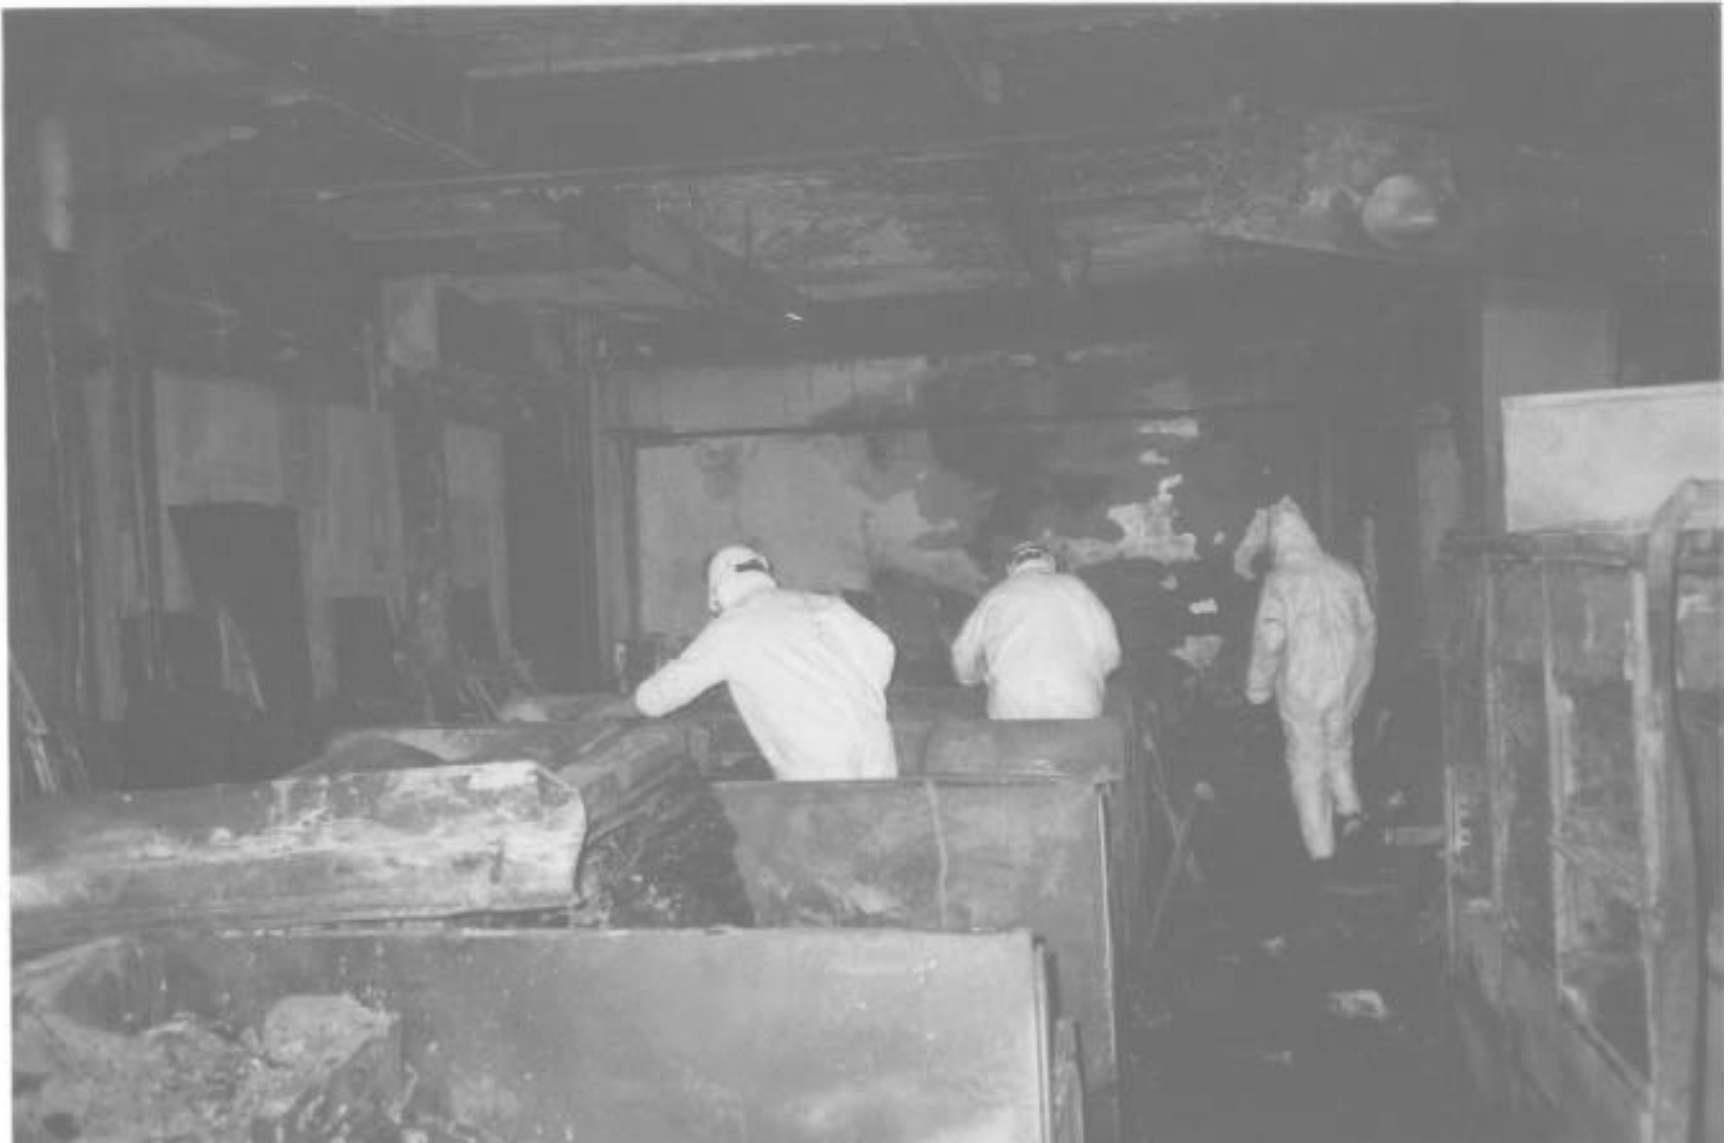
Investigators working in the area of fire origin wearing protective clothing due to asbestos contamination.
